TECHNICAL REPORT
TR-NAVFAC-EXWC-PW-1303
SEPTEMBER 2013

**BUILDING INTEGRATED PHOTOVOLTAIC (PV)
ROOFS FOR SUSTAINABILITY AND ENERGY
EFFICIENCY**

ESTCP Number: EW-200813

September 2013

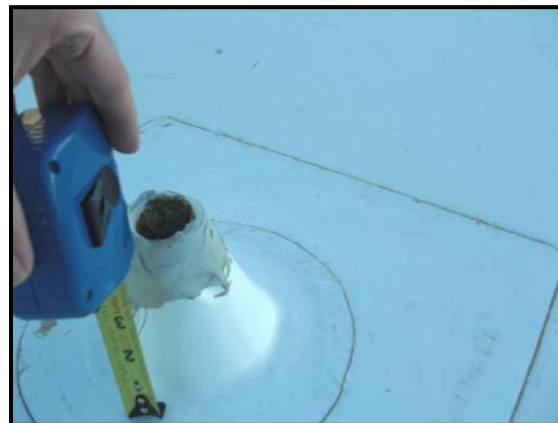
Figure-44: Photo of Site III (MCAS Yuma) air vent with insufficient flashing height.
